Bent Nail, Broken Mechanics: Effective Surgical Management of Femoral Non-union in Post-Polio Residual Paralysis – A Case Report

Abstract

Case Report: A 36-year-old male with PPRP presented with painful inability to bear weight following implant failure of a previously nailed femoral fracture. Radiographs showed hypertrophic non-union with a bent retrograde nail and screw back-out. Exchange nailing was performed using modified positioning to accommodate severe PPRP-related deformities.

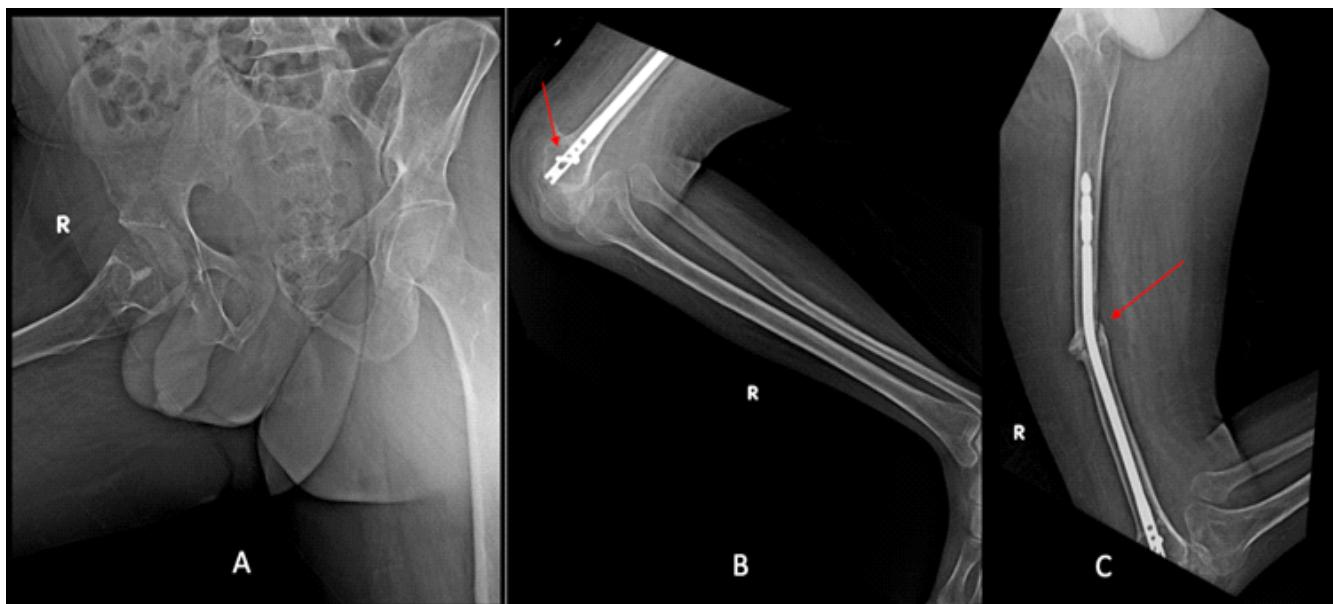
Figure 1: (a, b, c) show the pre-operative radiographs with a bent retrograde femur intramedullary nail in situ with hypertrophic non-union.

3-cm, fixed internal rotation, and flexion deformity of the hip, along with fixed external rotation and valgus positioning of the knee. The patella was laterally displaced and a fixed flexion deformity of 25° was observed, attributed to his underlying PPRP. Visible swelling was noted at the junction of the middle and distal third of the right thigh, with the presence of previous surgical scars. Localized tenderness and pain-induced restriction of motion at the hip and knee joints were present. No neurovascular deficits were detected. Radiographic evaluation revealed hypertrophic non-union at the previous fracture site, accompanied by a bent retrograde intramedullary nail and distal locking screw back-out, consistent with implant failure (Fig. 1). Given the distorted femoral anatomy and mechanical implant

failure, the patient was planned for implant removal followed by exchange nailing after thorough preoperative planning. During surgery, the patient was positioned with the knee flexed to 50°, exceeding the standard 30°, to accommodate the PPRP-associated deformity. Through a 5-cm incision along the old scar over the inferior patellar pole, the entry point was exposed after retracting the patellar tendon laterally. Under fluoroscopic guidance, proximal and distal locking screws were removed and the non-union site was opened. Hypertrophic non-bridging callus and femoral bending were noted. Gentle manual manipulation corrected the deformity without causing further fracture. Using a slap hammer and continuous fluoroscopic navigation, the old nail was extracted through the opened non-

demonstrate minimal callus and poor biological response [5]. The hypertrophic non-union in our patient was identified by a prominent callus at the fracture site alongside implant failure, confirmed by the bent retrograde intramedullary nail and backing out of the distal screw. This mechanical failure perpetuated instability and inhibited union, which is consistent with the known pathophysiology of implant fatigue in a biologically active but mechanically compromised environment [6]. Such presentations require surgical intervention focused on improving mechanical stability while supporting biological healing [6,7].

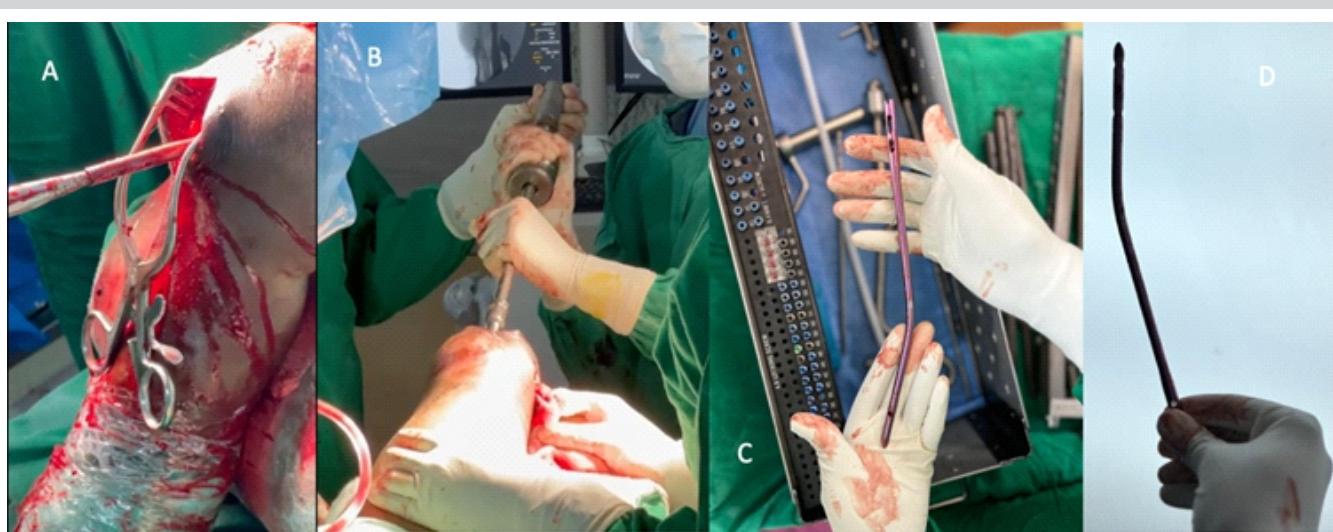
Figure 2: (a) The position of the knee while inserting the nail removal bolt into the nail. (b) The removal of the nail through a slap hammer. (c and d) The extracted bent retrograde femur intramedullary nail.

union site (Fig. 2). Acute docking of the non-union was achieved with bone reduction forceps, followed by insertion of a guide wire. Sequential reaming was conducted and a larger diameter, longer intramedullary nail was implanted with proximal and distal locking screws placed. The wound was closed in layers.

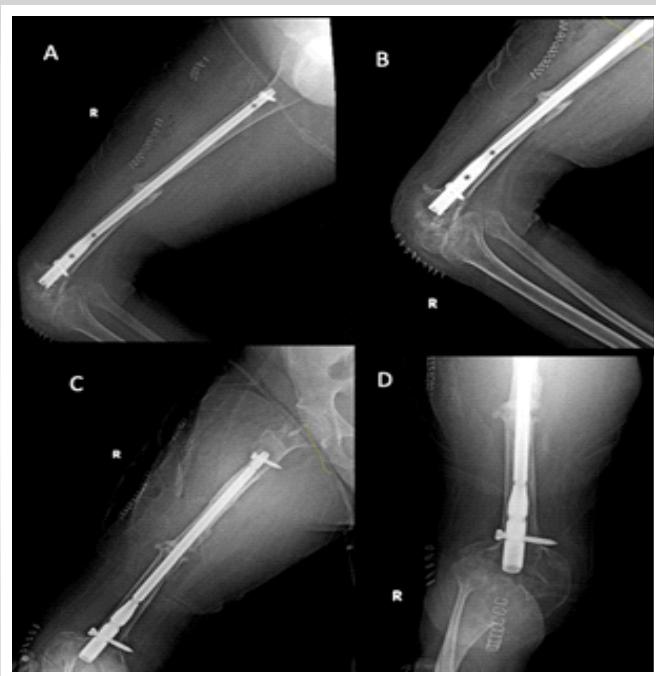
Figure 3: (a, b, c, d) depict the post-operative radiographs of the entire length of the femur and knee in anteroposterior and lateral views showing the correction of the deformity, acute docking at non-union site and exchange nailing.

Postoperatively, no complications were noted with radiographs showing proper alignment of the femur with implants in situ (Fig. 3). A tailored physiotherapy program was administered for 4 months (Table 1). At 1-year follow-up, radiographs confirmed fracture consolidation without peri-implant osteolysis (Fig. 4). The patient achieved knee flexion up to 90°, ambulated full weight-bearing without support or pain and limb length discrepancy was managed effectively with a heel raise (Fig. 5).

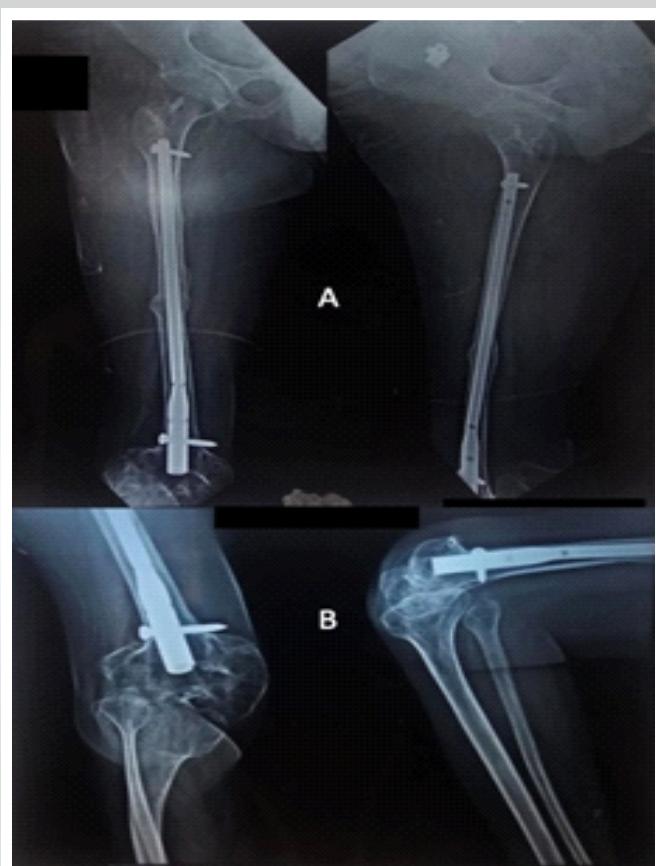
Figure 4: Images (a and b) show the 1-year follow-up radiographs of the patient showing complete consolidation of the non-union site with bridging callus and not peri-implant osteolysis.

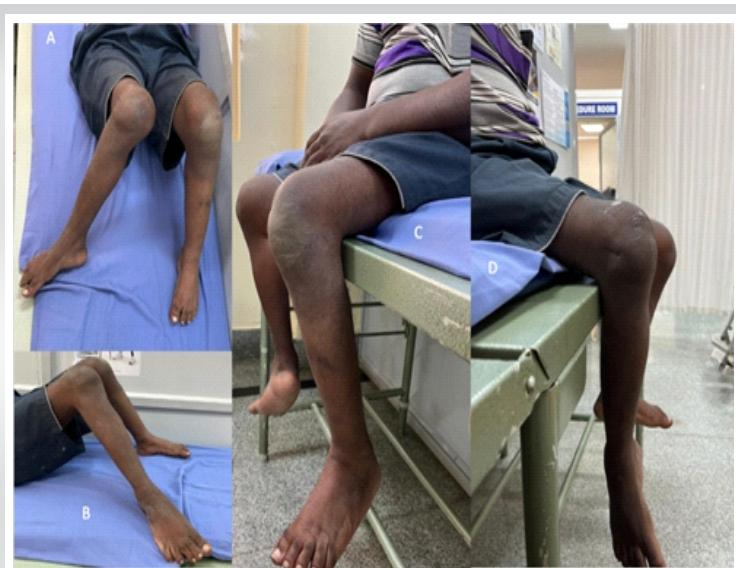
Figure 5: (a, b, c, d) depict the clinical presentation of the patient with achieving up to 90° range of motion at knee with pain-free weight-bearing walk without assistance.
